# Uniform Mitigation Verification Inspection Form

Inspection Date: 06/04/2015		
<b>Owner Information</b>		
Owner Name: Thousand Oaks Condominium		Contact Person:
Address: 203 S. Orchard Street BLDG 1		Home Phone:
City: Ormond Beach	Zip: 32174	Work Phone:
County: Volusia		Cell Phone:
Insurance Company:		Policy #:
Year of Home: 1984	# of Stories: 1	Email:

Uniform Wind Mitigation Inspection Pictures  
203 S.Orchard Street BLDG 1  
Ormond Beach, FL

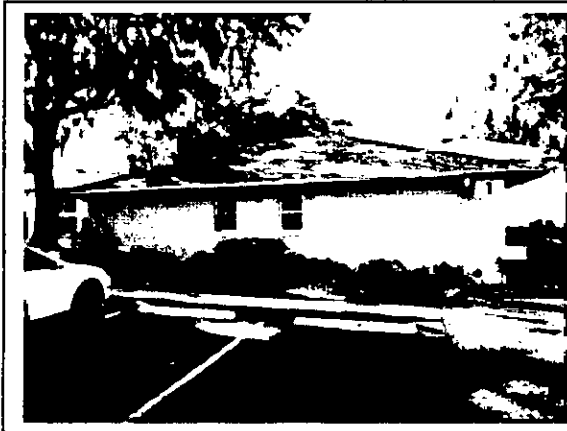
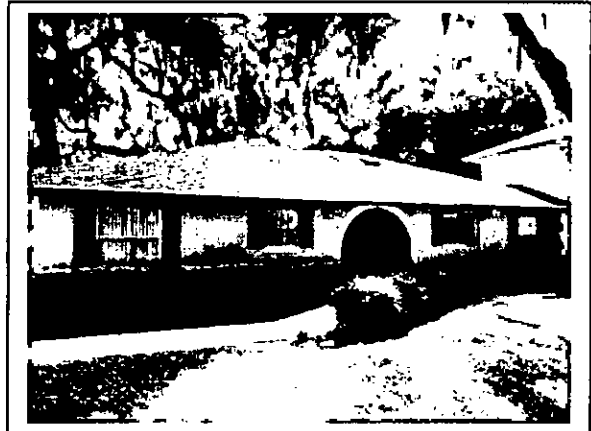
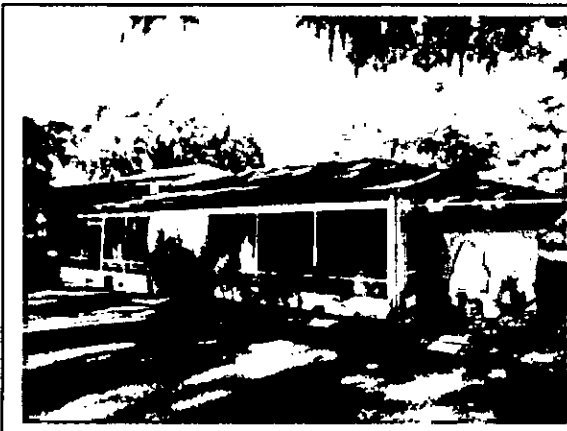
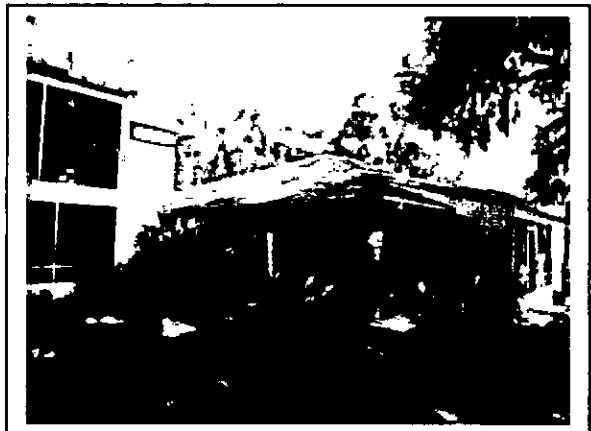
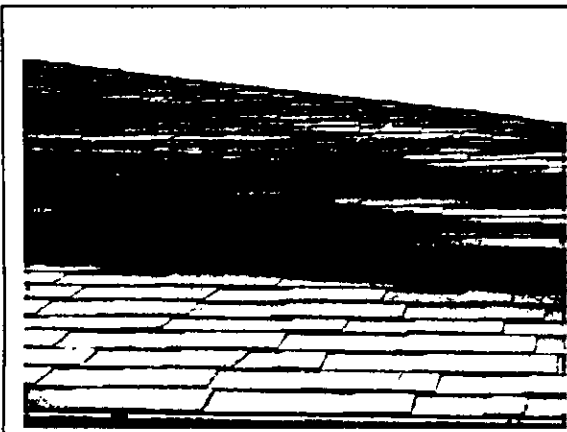
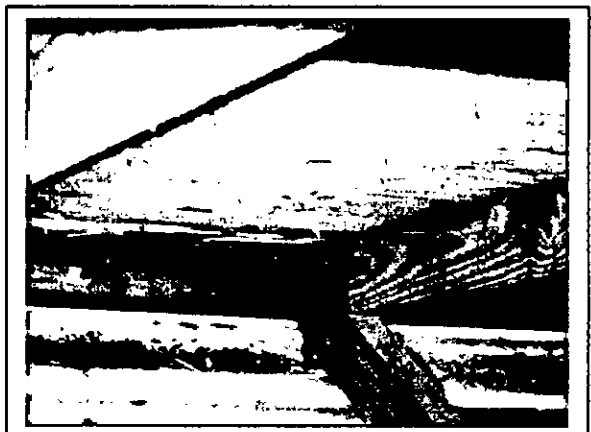
- ☒ C. Plywood/OSB roof sheathing with a minimum thickness of 7/16" inch attached to the roof truss/rafter (spaced a maximum of 24" inches o.c.) by 8d common nails spaced a maximum of 6" inches in the field. -OR- Dimensional lumber/Tongue & Groove decking with a minimum of 2 nails per board (or 1 nail per board if each board is equal to or less than 6 inches in width). -OR- Any system of screws, nails, adhesives, other deck fastening system or truss/rafter spacing that is shown to have an equivalent

☒ B. Clips

- ☒ Metal connectors that do not wrap over the top of the truss/rafter, **or**
- ☐ Metal connectors with a minimum of 1 strap that wraps over the top of the truss/rafter and does not meet the nail position requirements of C or D, but is secured with a minimum of 3 nails.

- ☒ A. Hip Roof      Hip roof with no other roof shapes greater than 10% of the total roof system perimeter.  
Total length of non-hip features: \_\_\_\_\_ feet; Total roof system perimeter: \_\_\_\_\_ feet
- ☐ B. Flat Roof      Roof on a building with 5 or more units where at least 90% of the main roof area has a roof slope of less than 2:12. Roof area with slope less than 2:12 \_\_\_\_\_ sq ft; Total roof area \_\_\_\_\_ sq ft
- ☐ C. Other Roof      Any roof that does not qualify as either (A) or (B) above.
