Uniform Mitigation Verification Inspection Form

Inspection Date: 06/04/2015		
Owner Information		
Owner Name: Thousand Oaks Condominium		Contact Person:
Address: 203 S. Orchard Street BLDG 3		Home Phone:
City: Ormond Beach	Zip: 32174	Work Phone:
County: Volusia		Cell Phone:
Insurance Company:		Policy #:
Year of Home: 1984	# of Stories: 2	Email:

Uniform Wind Mitigation Inspection Pictures
203 S.Orchard Street BLDG 3
Ormond Beach, FL

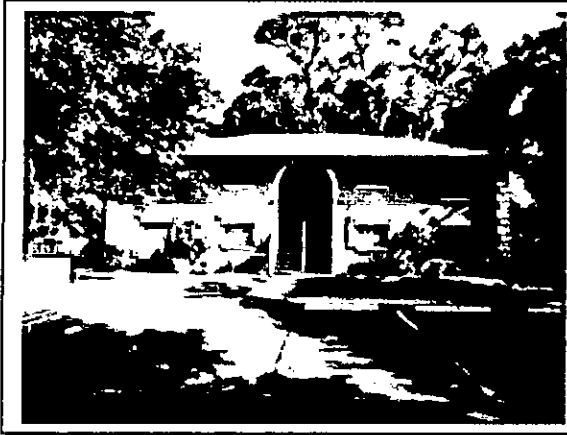
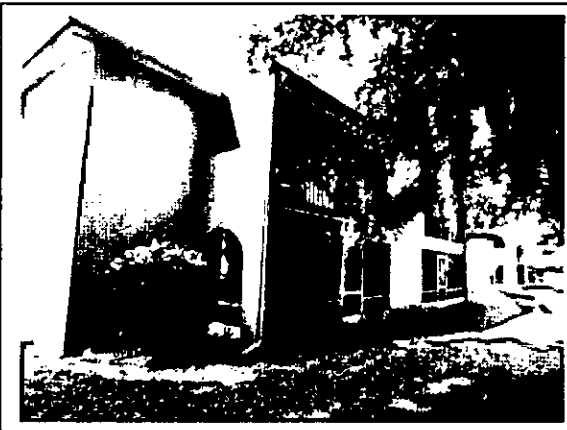
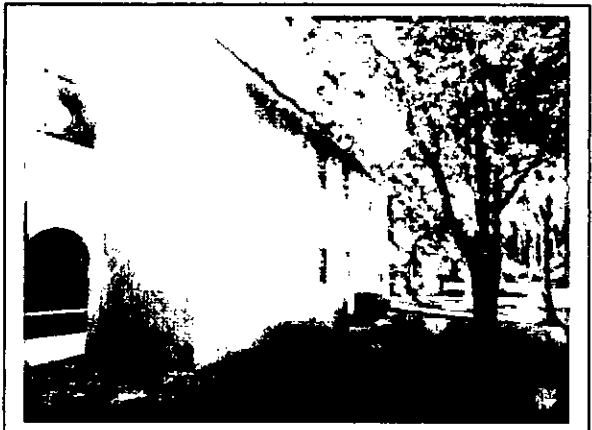
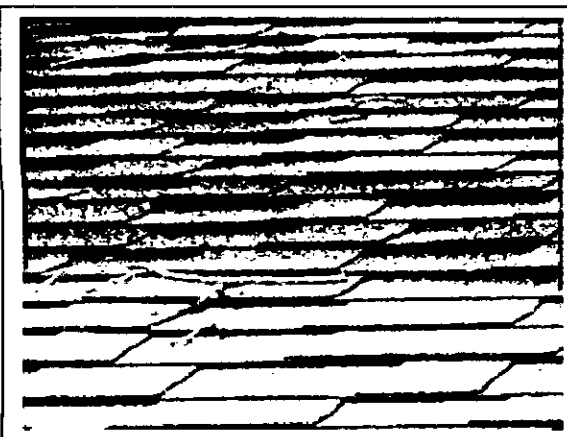
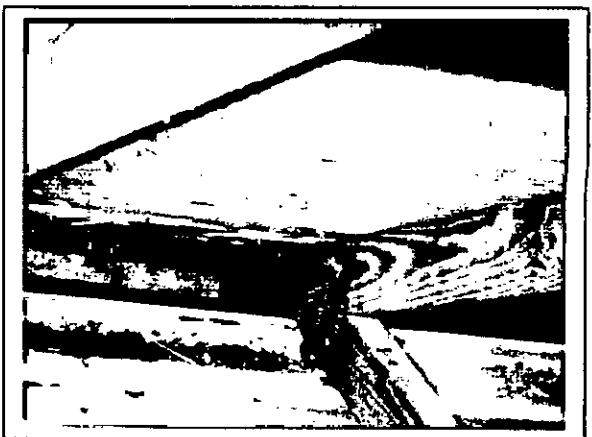
- ☒ C. Plywood/OSB roof sheathing with a minimum thickness of 7/16" inch attached to the roof truss/rafter (spaced a maximum of 24" inches o.c.) by 8d common nails spaced a maximum of 6" inches in the field. -OR- Dimensional lumber/Tongue & Groove decking with a minimum of 2 nails per board (or 1 nail per board if each board is equal to or less than 6 inches in width). -OR- Any system of screws, nails, adhesives, other deck fastening system or truss/rafter spacing that is shown to have an equivalent

- ☒ B. Clips
 - ☒ Metal connectors that do not wrap over the top of the truss/rafter, **or**
 - ☐ Metal connectors with a minimum of 1 strap that wraps over the top of the truss/rafter and does not meet the nail position requirements of C or D, but is secured with a minimum of 3 nails.

- ☒ A. Hip Roof Hip roof with no other roof shapes greater than 10% of the total roof system perimeter.
Total length of non-hip features: _____ feet; Total roof system perimeter: _____ feet
- ☐ B. Flat Roof Roof on a building with 5 or more units where at least 90% of the main roof area has a roof slope of less than 2:12. Roof area with slope less than 2:12 _____ sq ft; Total roof area _____ sq ft
- ☐ C. Other Roof Any roof that does not qualify as either (A) or (B) above.
