# Uniform Mitigation Verification Inspection Form

Inspection Date: 06/04/2015		
<b>Owner Information</b>		
Owner Name: Thousand Oaks Condominium		Contact Person:
Address: 203 S. Orchard Street BLDG 8		Home Phone:
City: Ormond Beach	Zip: 32174	Work Phone:
County: Volusia		Cell Phone:
Insurance Company:		Policy #:
Year of Home: 1984	# of Stories: 2	Email:

Uniform Wind Mitigation Inspection Pictures  
203 S.Orchard Street BLDG 8  
Ormond Beach, FL

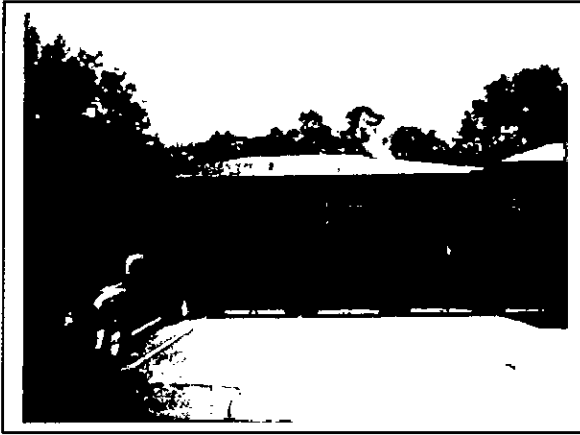
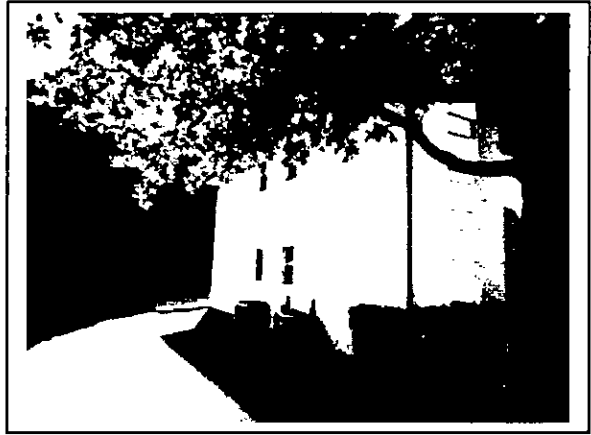
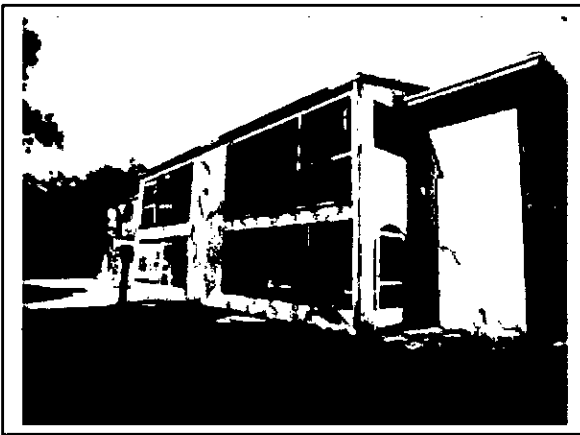
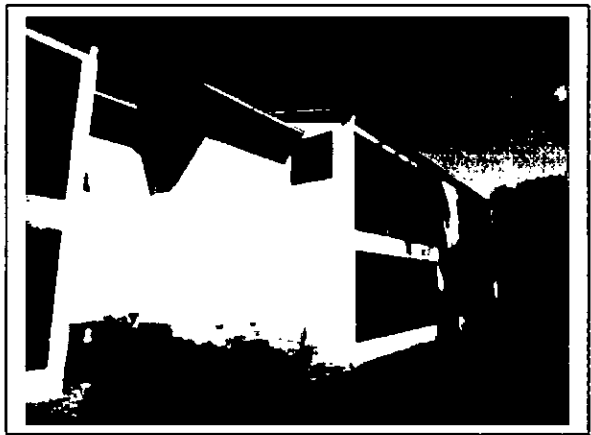
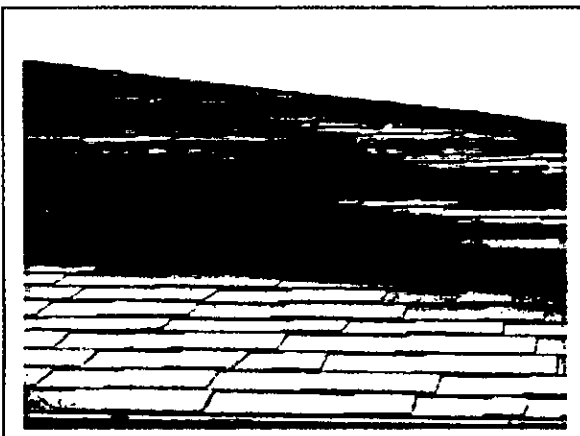
2.1 Roof Covering Type:	Permit Application Date	FBC or MDC Product Approval #	Year of Original Installation or Replacement	No Information Provided for Compliance
<input checked="" type="checkbox"/> 1. Asphalt/Fiberglass Shingle	____/____/____	_____	2015	<input type="checkbox"/>
<input type="checkbox"/> 2. Concrete/Clay Tile	____/____/____	_____	_____	<input type="checkbox"/>
<input type="checkbox"/> 3. Metal	____/____/____	_____	_____	<input type="checkbox"/>
<input type="checkbox"/> 4. Built Up	____/____/____	_____	_____	<input type="checkbox"/>
<input type="checkbox"/> 5. Membrane	____/____/____	_____	_____	<input type="checkbox"/>
<input type="checkbox"/> 6. Other _____	____/____/____	_____	_____	<input type="checkbox"/>

- ☒ C. Plywood/OSB roof sheathing with a minimum thickness of 7/16" inch attached to the roof truss/rafter (spaced a maximum of 24" inches o.c.) by 8d common nails spaced a maximum of 6" inches in the field. -OR- Dimensional lumber/Tongue & Groove decking with a minimum of 2 nails per board (or 1 nail per board if each board is equal to or less than 6 inches in width). -OR- Any system of screws, nails, adhesives, other deck fastening system or truss/rafter spacing that is shown to have an equivalent

- ☒ Secured to truss/rafter with a minimum of three (3) nails, and
- ☒ Attached to the wall top plate of the wall framing, or embedded in the bond beam, with less than a 1/2" gap from the blocking or truss/rafter and blocked no more than 1.5" of the truss/rafter, and free of visible severe corrosion.

- ☒ B. Clips
  - ☒ Metal connectors that do not wrap over the top of the truss/rafter, or
  - ☐ Metal connectors with a minimum of 1 strap that wraps over the top of the truss/rafter and does not meet the nail position requirements of C or D, but is secured with a minimum of 3 nails.

- ☒ A. Hip Roof Hip roof with no other roof shapes greater than 10% of the total roof system perimeter.  
Total length of non-hip features: \_\_\_\_\_ feet; Total roof system perimeter: \_\_\_\_\_ feet
- ☐ B. Flat Roof Roof on a building with 5 or more units where at least 90% of the main roof area has a roof slope of less than 2:12. Roof area with slope less than 2:12 \_\_\_\_\_ sq ft; Total roof area \_\_\_\_\_ sq ft
- ☐ C. Other Roof Any roof that does not qualify as either (A) or (B) above.
